Water Quality Plots 1

Replacing what proved to be a troublesome, unreliable monitoring system with another that proved more robust, that helped salvage research, and allowed a successful transition into the new water quality project.

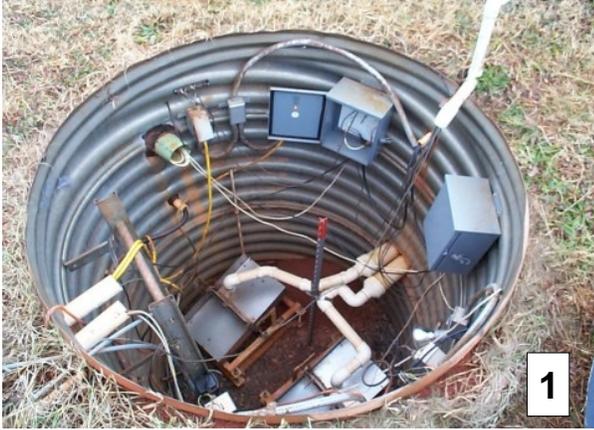
1. Drainage Pit before removing unsafe and impractical electrical outlets.
2. Drainage Pit after relocating electrical outlets to a safer above ground enclosure.
3. Old plot setup - flumes and ultrasonics exposed to rain, wires in way of maintenance.
4. New plot setup - covers protect flumes, wires buried, solar panels more reliable and efficient means of maintaining battery voltage.
5. Old ultrasonic runoff measurement device that proved unreliable.
6. Closeup of ultrasonic devices showing problematic circuit board.
7. New runoff measurement setup with pressure transducer.
8. Closeup of pressure transducer. Not susceptible to moisture problems.
